Post-Impact Investigation of CFRP Laminated Plate

Abstract

This paper deals with low-velocity impact and quasi-static indentation tests on carbon fibre reinforced plastic (CFRP) laminates that classically used in aeronautical applications. The aim is to carry out post-impact analysis using Vic 3-D digital image correlation to investigate the behaviour of permanent indentation which is an important condition for the damage tolerance justification in composite. Result shows the indentation depth decreased with the time due to relaxation of the specimen until at certain position. The microscopic observations were carried out to understand the phenomenon. Besides that, the post-mortem analyses on the impacted plate were also carried out through microscopic observation to determine the delamination area at each interface which is normally difficult to extract from the C-Scan result. The observations were made at three different sections cut (0°, 90° and 45°). The results of delamination area obtained from both microscopic and C-scan analysis is compared and there are rather satisfying to each other.

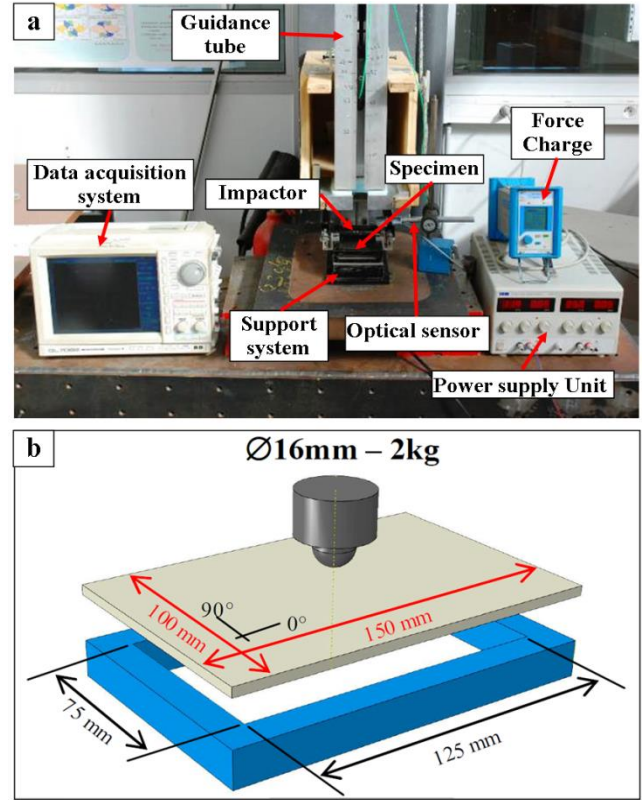
Figure 1 (a) The arrangement of the impact test (b) Boundary condition of the impact test

Impact tests were performed using a drop tower system with an impactor with 8 mm radius and 2 kg mass as shown in Figure 1a. The test is according to the guidelines from the standards ASTM D7136/D7136M [14]. The specimen was placed under the drop tower with simply supported on a of 75 mm x 125 mm frame, as shown in Figure 1b. The test was performed at impact energy of 25 J. This energy provides sufficiently different damage mechanisms around the BVID threshold and does not reach the perforation level [2,12]. During the test, the optical sensor, accelerometer and force sensor were installed to measure the impact forces, accelerations and optical signal for plate deflection. All the data were recorded using Yokogawa DL708 digital oscilloscope and acquired at the maximum rate of 200 kHz because the impact test is very dynamic that gives a wide range of frequencies.

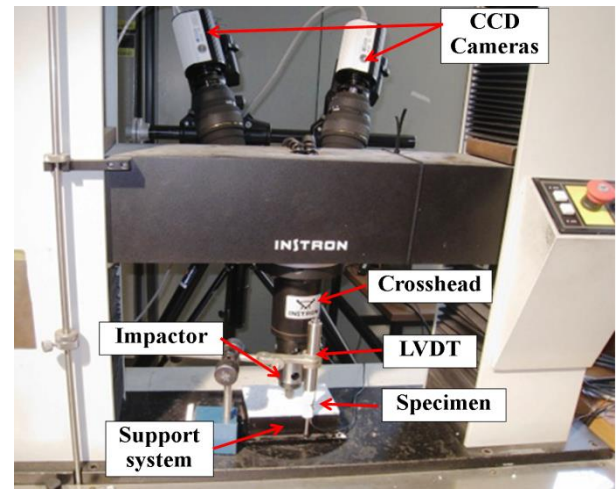
Figure 2 The indentation test arrangement on the test machine

The indentation test was done by using the Instron 4206 test machine. The set-up of the test can be seen in the Figure 2. The impactor is the same used in the impact tests. Similarly, the specimen was placed on a simple rectangular frame support as in impact test. The displacement of the impactor was controlled by the feed of the test machine's crosshead and the loading speed was set at 2 mm/min. The displacement was measured using Linear Variable Differential Transformer (LVDT) as this instrument allows more accurate values than the displacement measured by the test machine. The LVDT was installed parallel to

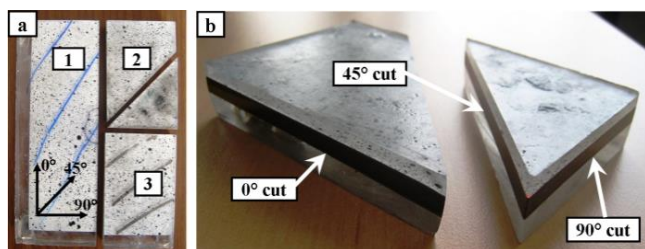
Figure 3 Specimen preparations for microscopic observation (a) the plate after being cut (b) The areas that were polished and observed (section no.2)

The microscopic analysis was done by using an optical microscope on both impacted specimens, T-dyna and T-static. First, the specimens were cut along the 0° and 90° through the impacted area as shown in Figure 3. After the microscopic observations have been done at both sections, only then the 45° section was cut. However, before cutting, the specimens are immersed in resin together with chemical hardener (catalyse polyester peroxide) to make sure the debris will not be removed during the cutting and polish processes as demonstrated in [15]. These microscopic observations were made to study the debris behaviour inside the crack areas and also to measure the crack length between the interfaces that occurred after the plate being impacted. The measurement of the crack length can be used to

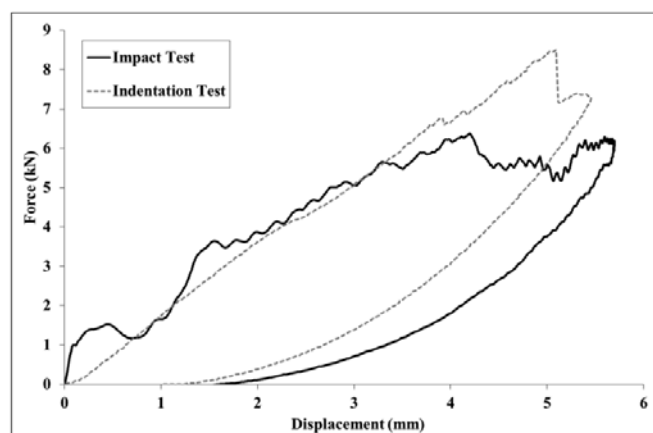
Figure 4 The comparison of force-displacement curves between impact and indentation tests

Between the impact and the indentation test, there is one parameter in common, namely the maximal displacement of the impactor. Therefore, a good possibility is given to compare the results of these two different tests. Although the maximal displacement of 5.7 mm was shown by the LVDT machine, however Figure 4 shows that the maximal displacement is only achieved by 5.4 mm. This is probably caused by error in setting LVDT machine at the beginning of the test. This difference is neglected for further analysis. Besides that, the force curve increased linearly longer in the indentation test than in the impact test. Moreover, the force at the same respective displacement is larger in the case of the impact test than the indentation test. From previous studies [11], this phenomenon is explained due to the inertia effect that occurs during the impact test because of the

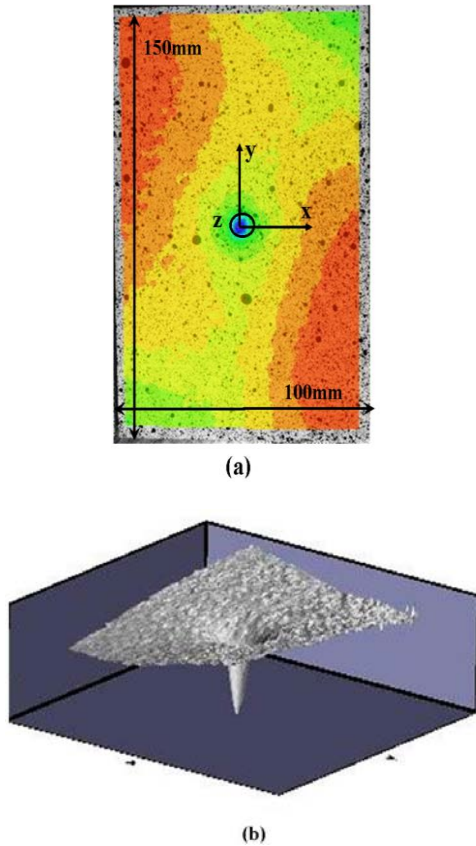
Figure 5 The Image from Vic 3-D Digital Image Correlation (a) Coordinate system and size (b) The twisted shape of specimen after being damage

A further criterion to assess the damage caused by an impact test or static test is the indentation depth of the plate at where the impactor has knocked. The characteristics of the permanent indentation after certain relaxation are one of the main interests in this study. Therefore, the indentation depth of both specimens; T-dyna of impact test and T-static of static test were measured. A series of 3D images of the damaged specimen has been taken for a few days after the tests to measure the plate's indentation by using the CCD-cameras. The indentation was observed directly after the test. From the CCD-camera systems, it gave the contour plot images of the specimen by using Vic Snap and Vic 3-D Digital Image Correlation as shown in Figure 5a. These contour plot images were used for the determination of the indentation. The indentation can be seen in the middle of the plates as shown in Figure 5b. Besides that, a global deformation of the specimens can be marked. The specimen has a twisted shape after being damaged because of the plasticity of the resin (Figure 5b) even though the resin's characteristic is brittle. However, the plasticity can occur in this case.

The taken images were marked as Z001, Z002, Z010 and so on. The number 001 or 006 are representing the first image or the

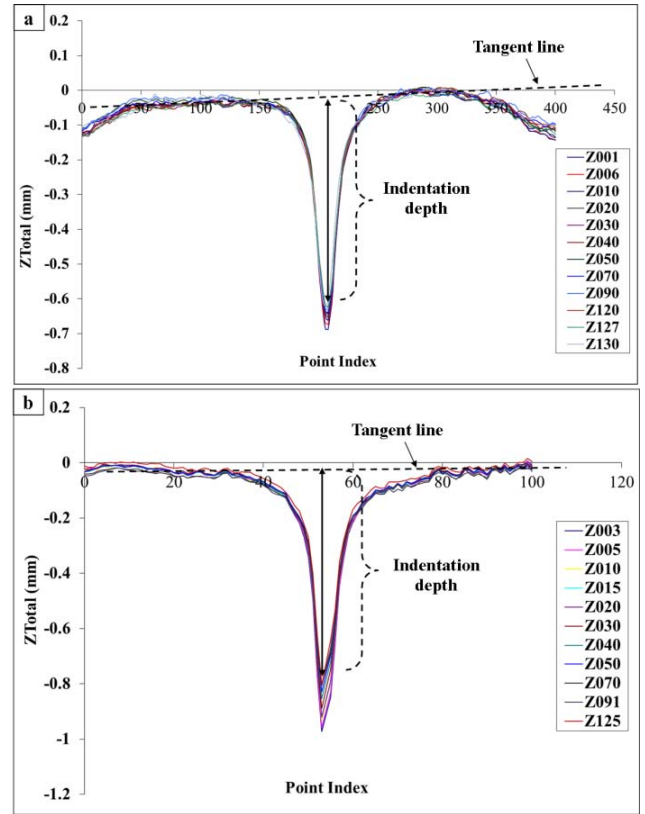
Figure 6 The indentation depth measurements (a) impact test) (b) indentation test

sixth image taken by the CCD camera and Z is representing the displacement in Z-direction. One tangent line was drawn approximately in the middle between the curves. The indentation depths were measured from the point on the tangent line to the lowest peaks of each curve as in the Figure 6.

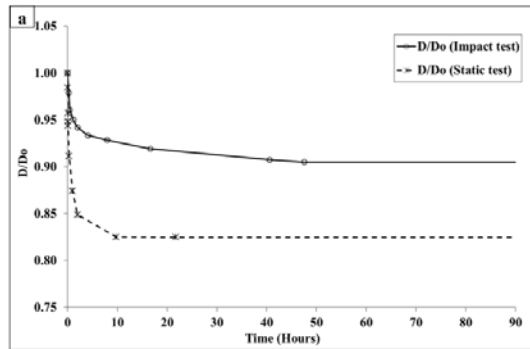
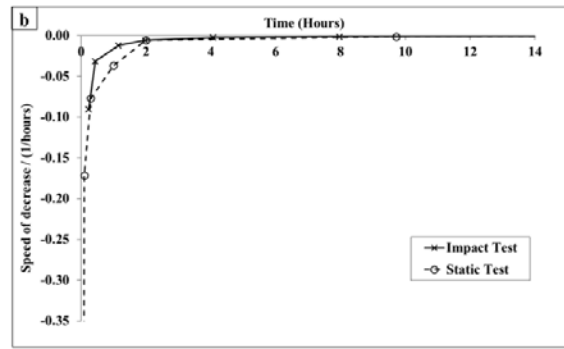
Figure 7 (a) The percentage of evolution indentation depth of each test (b) The comparison of speed of decrease for both tests

Thus, by knowing these data the curve of relaxation of the indentation depth were plotted as shown in the Figure 7a. As a result, the characteristics of indentation depth after certain period of time were as expected, the depth will decrease due to relaxation of the specimen. The difference between temporary and permanent indentation depth for impact test is $\approx 10\%$ and $\approx 18\%$ for the static test. In reality, the initial indentation depth (D_0) for both cases is difficult to obtain, especially for the impact test. Hence, in this study the D_0 value is assumed as the indentation depth of the first picture which was taken just after either the impact or the static test. Therefore, there is always a gap between the original D_0 and the assumed D_0 depending on how fast the first picture was taken. For both tests, when the plate gets unloaded, the deformation which occurred on the plate tries to back its initial location due to the elasticity of the material that is called the plate relaxation. The debris can prevent that relaxation, the better it is distributed the higher is that effect. It is obvious a better distribution can occurs during a static test because the debris has more time to fill the free space of the cracks [4,9].

Referring the speed of decrease for both tests, during the first 5 hours the indentation decreased dramatically but after that it started to decrease steadily. It is almost constant after 45 hours of the tests. Figure 7b has shown that the indentation depth of the plate performed under static test has greater decrease of speed than the impact test. The reason for this phenomenon was not yet found. The counting of fragment or debris of each plate through the microscopic observation could give some idea of this behaviour.

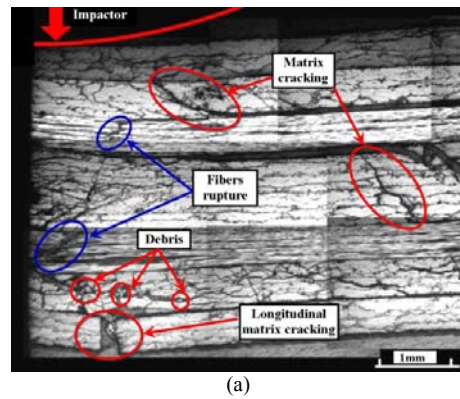
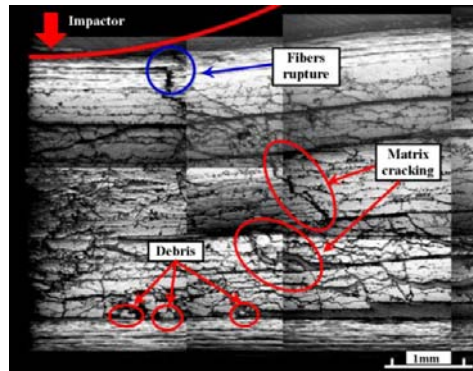
Figure 8 Some example of debris in the delamination areas and the matrices cracking for (a) Near to the impact of 90° cut and (b) Near to the impact of 0° cut

The microscopic observations on the 90° and 0° sections cut have shown that there are plentiful of debris exists in the delaminated areas in both sections. Besides the delamination between the interfaces, matrix cracking and fibres rupture are also exists in many areas as shown in Figure 8. Similarly, for the 45° section cut, there are also a lot of debris exists in the delaminated area. Therefore, it seems difficult to count the debris with the naked eyes. Hence, it can be concluded that the existing of these debris will tend to block the fibres and matrices of the specimen being impacted to return to its initial location. It will affect the relaxation of indentation. This could give the general explanation why in previous section the indentation depth became constant after certain period of times. When the crack areas became

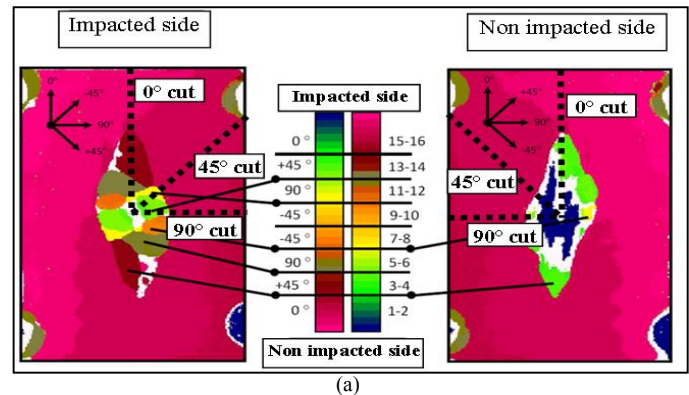
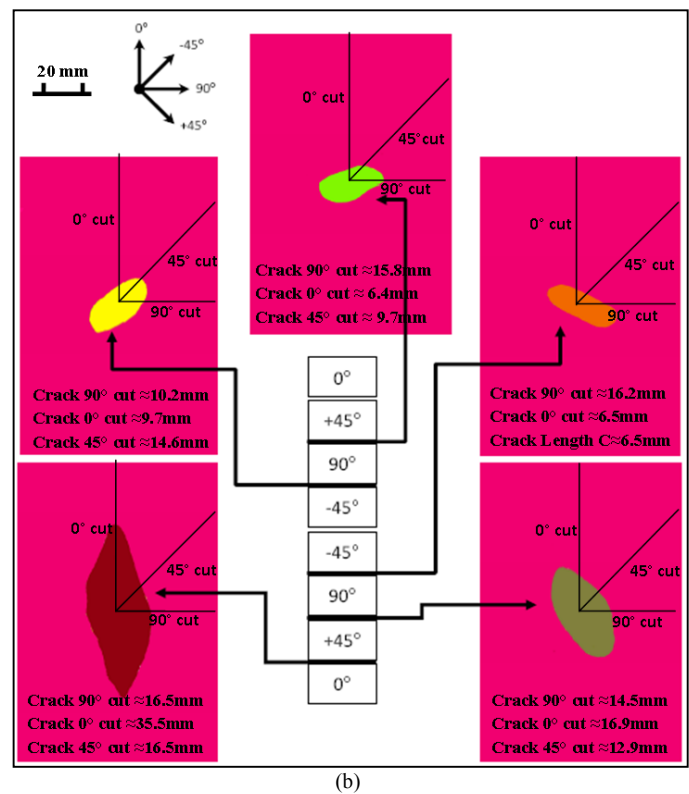
Figure 9 (a) General results from C-Scan (b) Approximation of delamination area for each interface

Delamination area of impacted plate taken from the C-scan analysis was measured for each interface as shown in Figure 9. The delaminated area of each interface presents in Figure 9b was approximately extracted from the Figure 9a. From the color ban (Figure 9a), the delamination area in each layer can be distinguished. Moreover, the C-scan result on the non-impacted side (Figure 9a) is necessary to make sure the areas of delamination were properly extracted. There was no delamination if the plies were in the same orientation such as four plies of -45° in the middle of the laminates.

For both microscopic observations on the 90° and 0° sections cut, the results obtained were rather satisfying compared to the C-scan result. However, for 45° section cut the results obtained by microscopic observation has shown that there are significant differences with the C-scan result. Referring to Figure 10c and Figure 11c, the longest crack occurred at $90^\circ/45^\circ$ interface with the length of 22.3 mm while for C-scan, the longest crack occurred at $0^\circ/45^\circ$ interface with length 16.5 mm. Besides that, the second longest crack is also different in both results where for the microscopic observation is 15.7 mm at $-45^\circ/90^\circ$ interface while for C-scan at the same interface, the approximation made are only 6.5 mm. Another important point to discuss is there was a short crack at $0^\circ/45^\circ$ interface in the microscopic observation. These major differences may be caused by the difficulties to see exactly the delaminated area on each interface from the general result of C-scan (Figure 9a).

other despite of some erroneous due the difficulties to see exactly the delaminated area on the 45° cut on the general result of C-scan (Figure 9a).

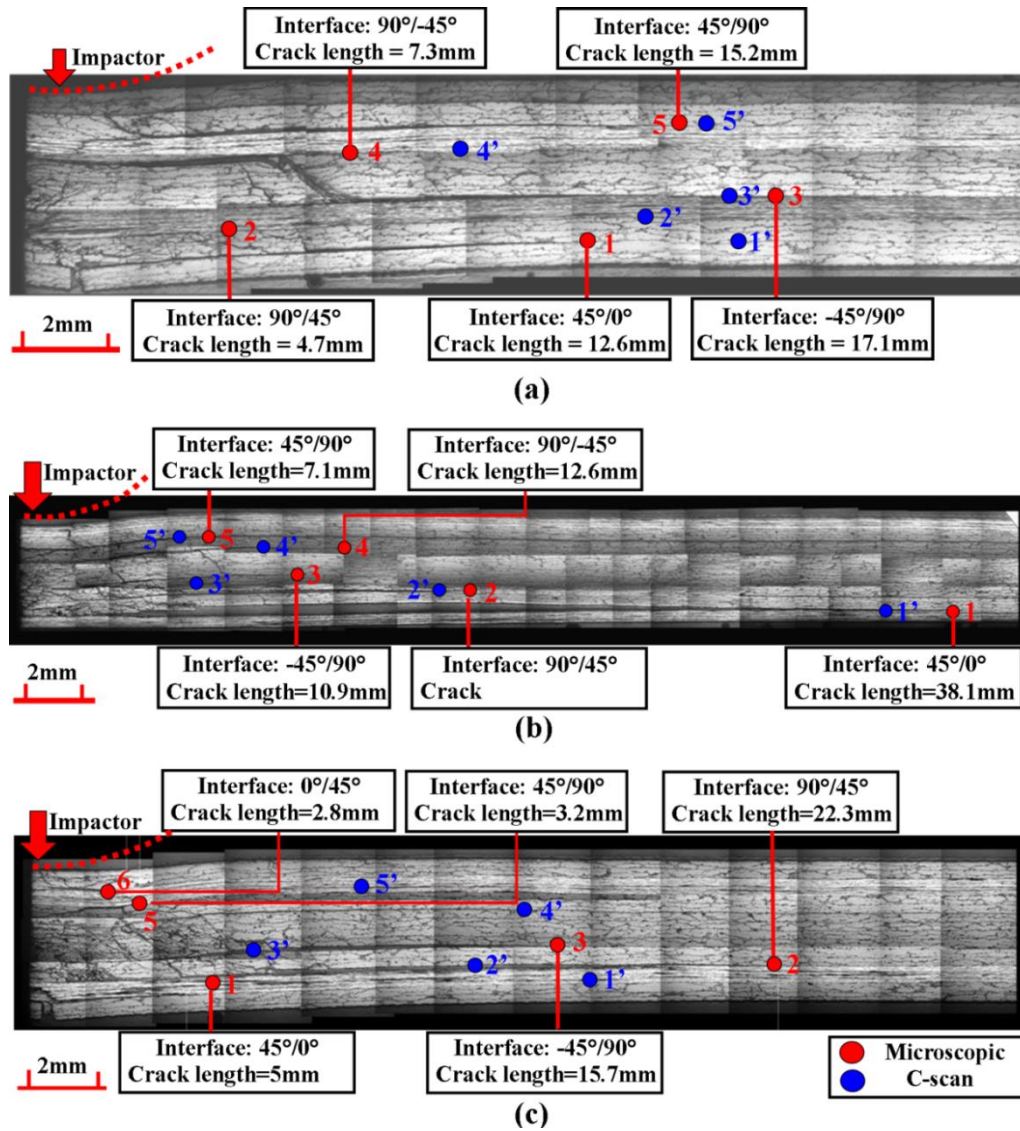
Figure 10 Results of delamination length by microscopic observation (a) 90° section cut (b) 0° section cut (c) 45° section cut

After that, the measurements of delamination length for each interface of C-scan result were compared with the delamination length calculated from the microscopic observation as presented in Figure 10.

Generally, the delamination length measured from both microscopic and C-scan analyses have some differences. For a better comparison, the measurements from these analyses were plotted in Figure 11. As can be seen in Figure 10 and Figure 11a, the longest crack measured through the microscopic image along the 90° section cut was between the $-45^\circ/90^\circ$ interface which is around 17.1 mm. Meanwhile for the C-scan, three different interfaces have almost the same longest crack around 16.2 mm. This is may be due to the minor error of the approximation process of delaminated area from the Figure 9a. Moreover, the C-scan results have shown that there are five interfaces encountered with delamination but from the microscopic observation, only four interfaces where the delamination can be clearly seen. The $45^\circ/90^\circ$ interface has only small delamination near to the impacted area.

The microscopic observation on 0° section cut has shown that the longest crack occurred at $45^\circ/0^\circ$ interface (38.1 mm) which is close to the C-scan result (35.5 mm) as presented in Figure 10b and Figure 11b. Besides that, the number of interfaces having delamination in both analyses is also similar with the delamination length of the other interfaces are compatible to each other.

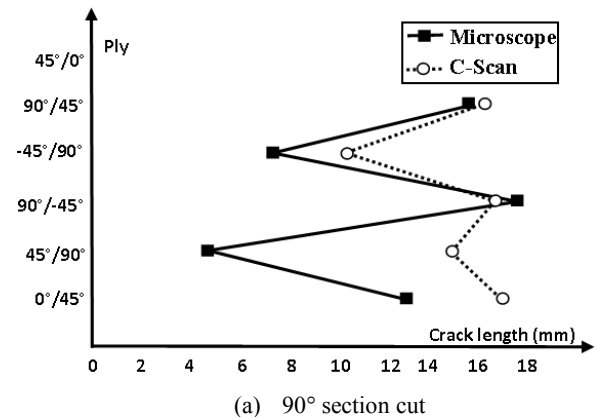
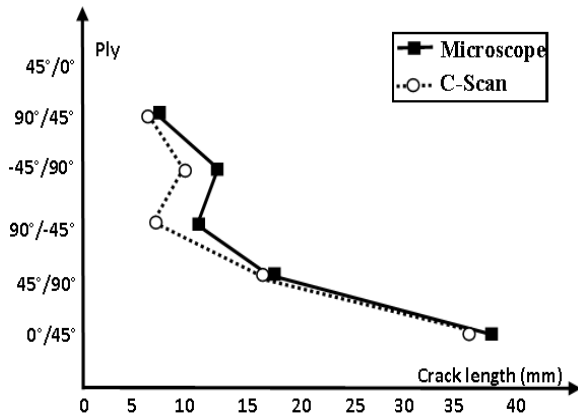
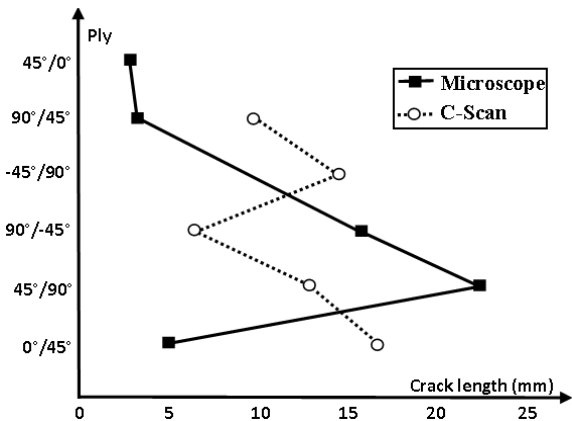
(b) 0° section cut

(c) 45° section cut

Figure 11 The results comparison of microscopic observation and C-scan
